# **Milton-Madison Bridge Project**

2013 Road School  
March 6, 2013

Kevin Hetrick  
Indiana Department of Transportation

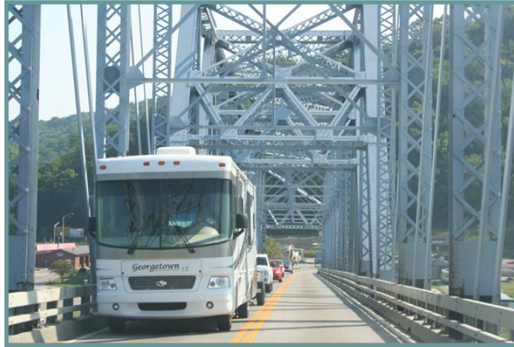
Functionally Obsolete

- Sufficiency Rating of 6.5 out of 100
- KYTC Structurally Deficient List

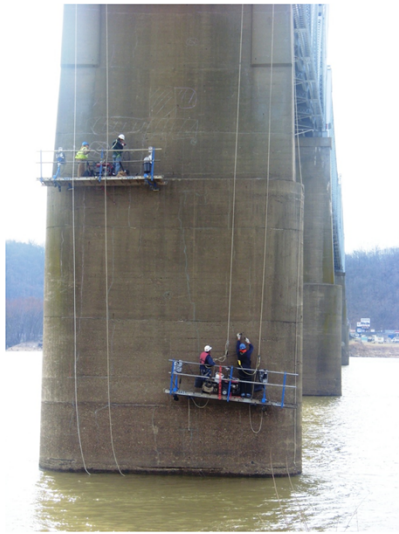
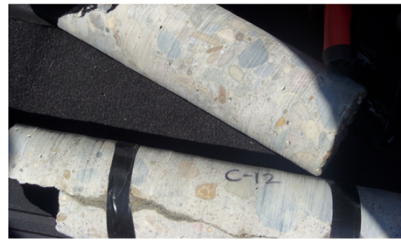
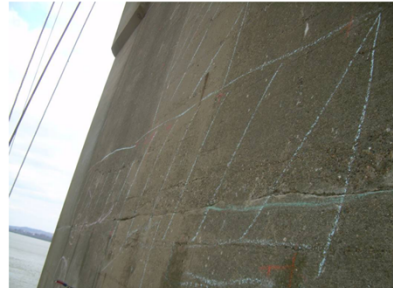
## Substantive Pier Inspection

- Physical Inspection Feb-Mar09
  - Non Destructive testing
  - Lab Testing of Samples
  - Existing Condition and Service life Assessment Reports

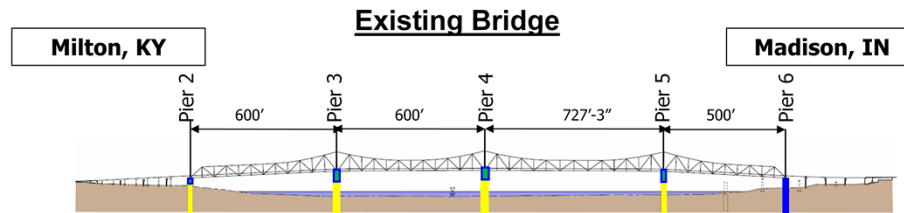
# Superstructure Replacement Profile

*Navigation Channel does not need to be widened*

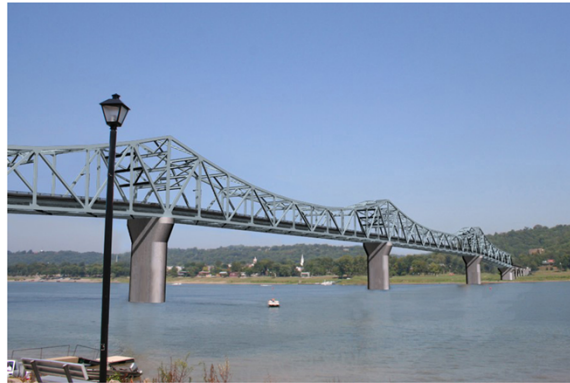
## Section 106 Commitments

Truss Profile “appearance” is established

Minimal Sway Bracing

TF-2 Rail

All Truss Piers have similar appearance

- New truss superstructure mimicking historic truss profile
- Free Ferry Service operating 24/7 between Milton & Madison
  - Plan to minimize disruptions from traffic using ferry
  - Temporary modifications at campground & boat ramp to create docks
- Funding for local programs to offset economic impacts of closure
  - Tourism/Marketing campaign in both cities
  - Historic Preservation Officer for Madison
  - Local business assistance through Madison Main Street Program
- Commitment to follow Section 106-like process on any future approach improvement projects (not programmed in either STIP)
- Measures to offset loss of historic bridge
  - Preserve builder plates from existing bridge
  - Photo documentation of existing bridge
  - Restoration of 1929 film of original bridge opening ceremony

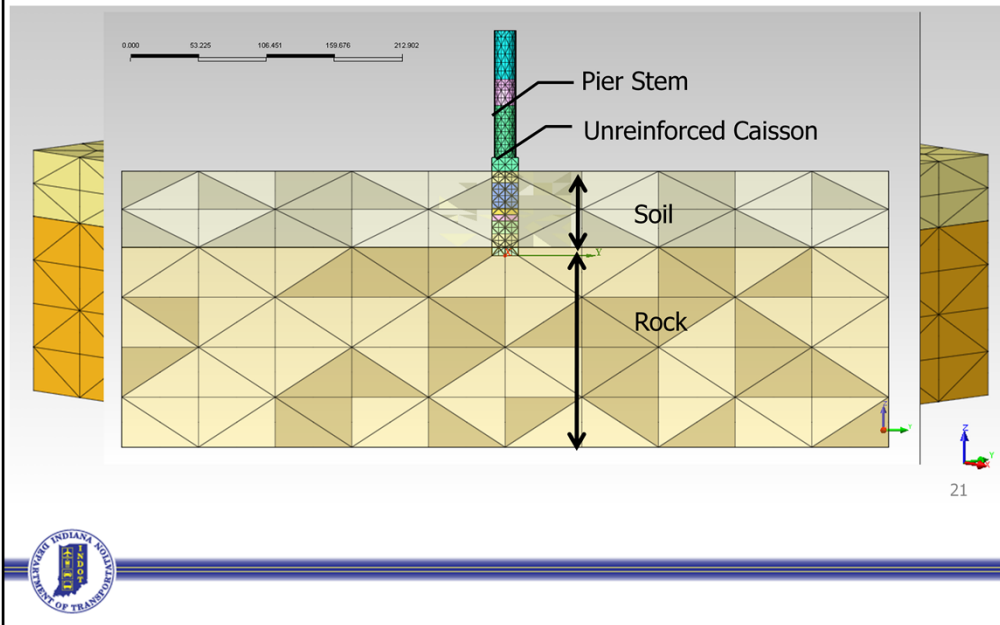
# Finite Element Method Required

**Soil Response**

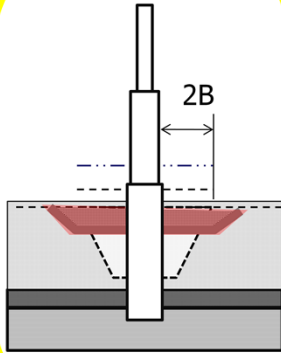
Rip Rap with  
Filter

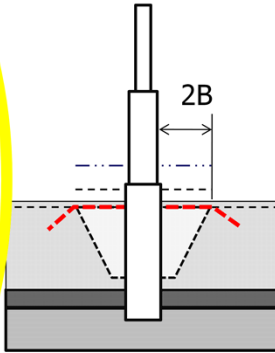
Articulated Block Mat

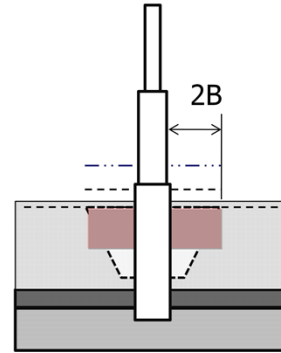
Jet Grouting

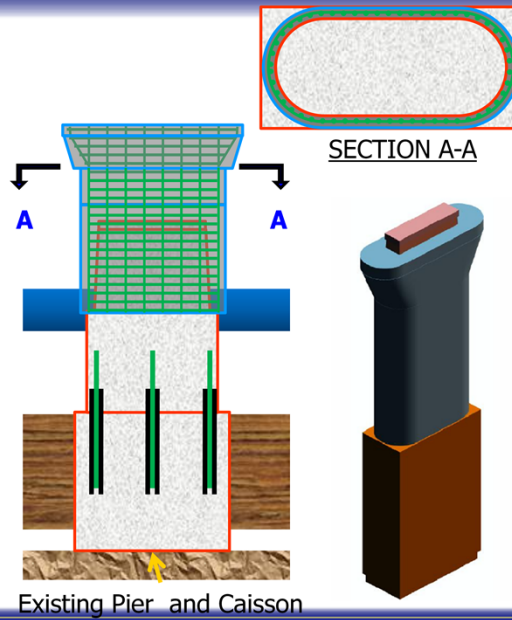
## Proposed Pier Strengthening

1. Drill holes into existing unreinforced caisson
2. Grout Rebar into Caisson
3. Add Stem Reinforcement
4. 2' thick encapsulation
5. Pier Cap Reinforcement
6. Form and Cast new Pier cap

## Strengthening of Existing Piers (Caissons)

Strengthening of the existing caissons shall have reinforcing placed 36" on center with intermediate # 11 reinforcing.

Coring only. No drilling, blasting or impact operations. Contractor to ensure that the operation does not affect the face of the caisson.

Place reinforcing steel and fill annular space with High Strength, Non-Shrink Grout.

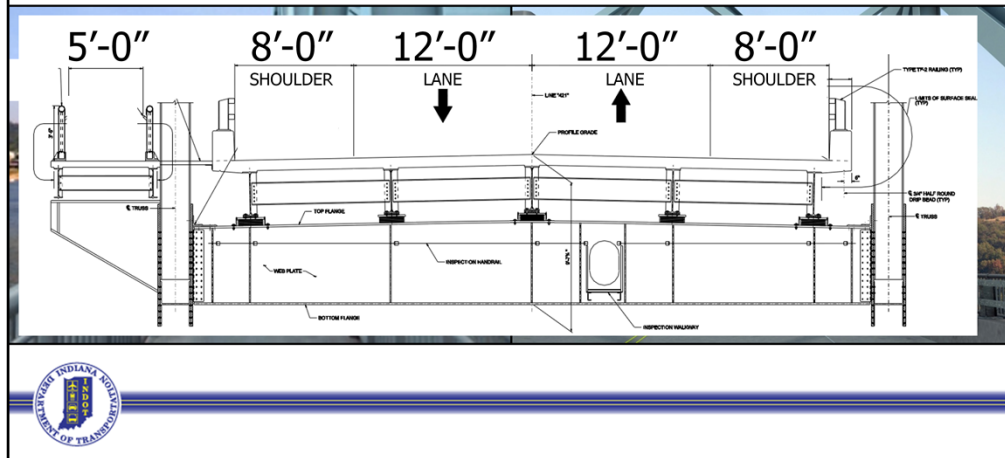
## New Structure Typical Section

- Existing Bridge clear width is 20'
- 5' pedestrian sidewalk

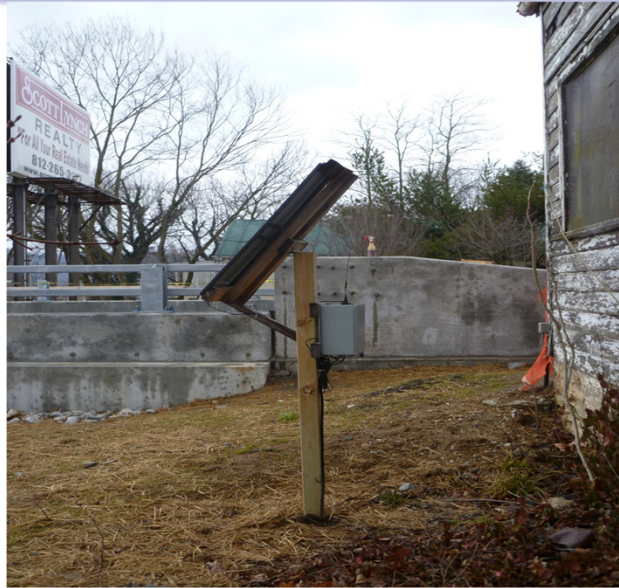
## Historic Structures (Vibration Monitoring)

Requirement to monitor construction vibration at three structures.

Perform pre and post construction inspections of the structures.

Submit a monitoring plan which details equipment, key personnel, daily logging, real time alerts and general protocol.

Specific threshold of 0.2 in/ second given (peak particle velocity).

Construction operations in the area would be stopped and a visual survey would be performed.

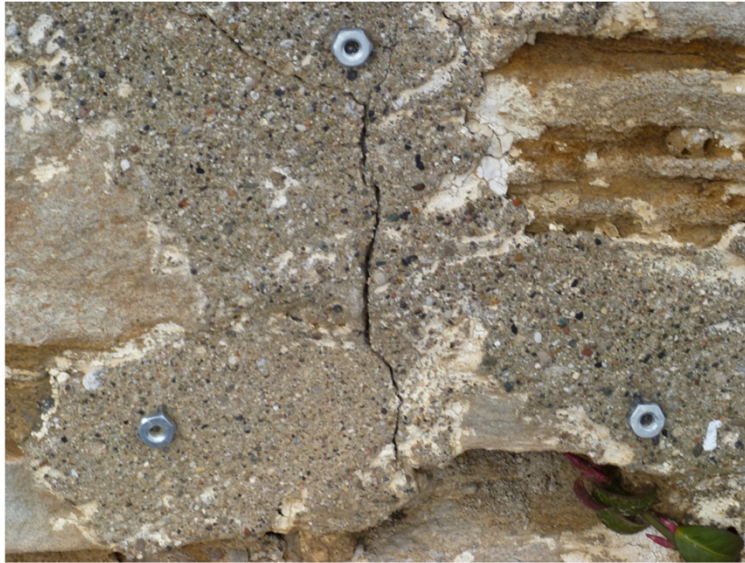
## Historic Structures (Foundation Monitoring)

Another requirement in addition to the vibration monitoring was the daily foundation crack monitoring to determine movement of structure.

Distance between fix points would be recorded.

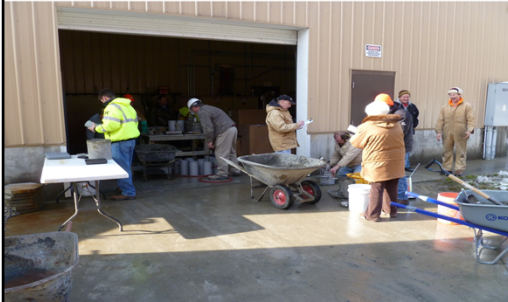
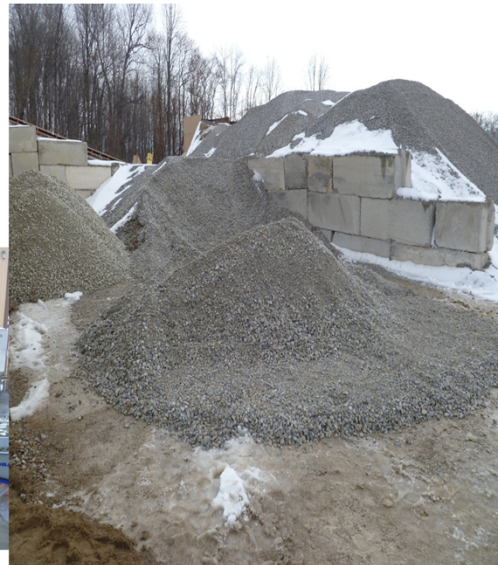
- 3 Cementitious Materials
- Paste Content @ 25%
- Alternate Aggregate Gradations
- Type F or Type G Admixtures
- Trial Batch

Cement, fly Ash and Silica Fume

Low Paste content

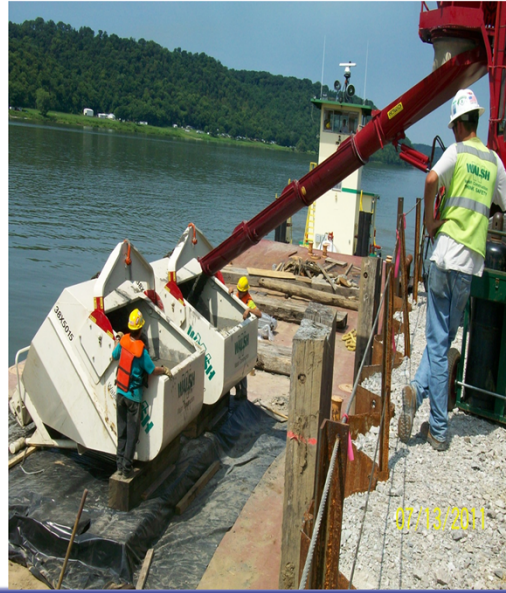
## High Performance Concrete (HPC)

- Sampling
  - Cylinders
  - Unit Weight
  - Air and Slump
  - Yield (Information Only)

Cylinders for compressive instead of flexural strength.

Cylinders for permeability testing also. Resistance to Chloride Ion Penetration.

½ cft bucket instead of ¼ cft yard for unit weight

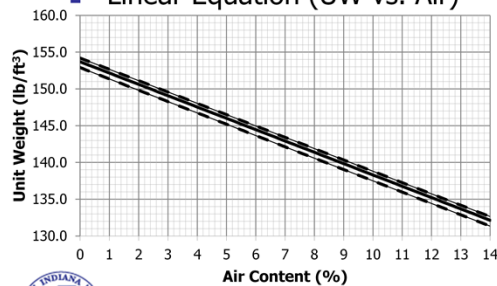
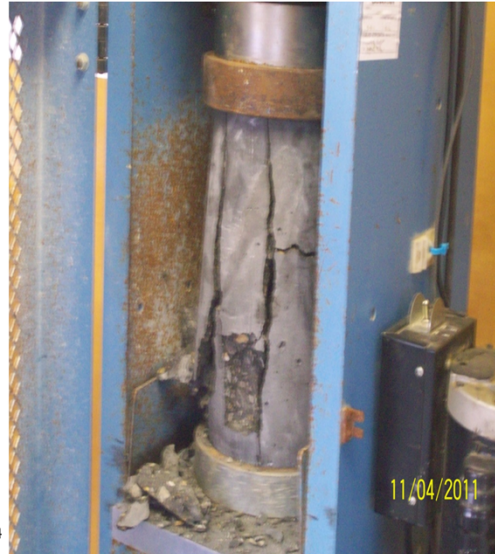
## High Performance Concrete (HPC)

Resistance to Chloride Ion Permeability Testing (OMM) 1500 coulombs limit at 56 days

Strength (On site testing trailer) 5000 psi

Air was targeted at 5%-8%

Slump range was increased. 4" to 7.5" allowed but must meet all other parameters including 25% paste. So no extra water to achieve slump.

Water/Cement ratio was required to be between 0.40 and 0.44

Linear Equation with upper and lower limits were based on trial batch. Unit weight and Air then plotted on the linear equation chart. Specific requirements for results outside of the required limits.

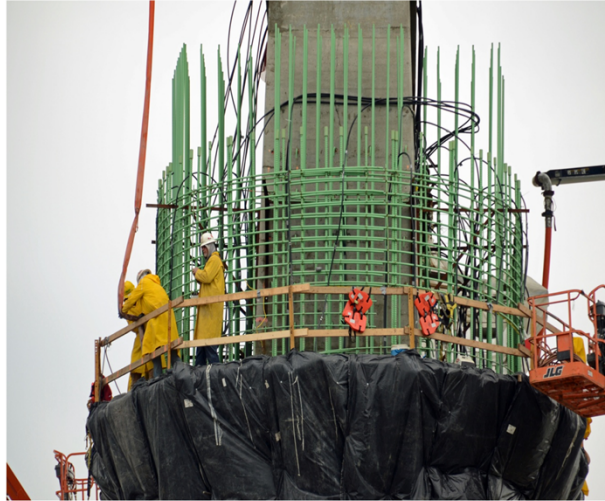
# High Performance Concrete (HPC)

- Mass Concrete
- Thermal Modeling
- Temperature Control
- Curing Methods
- Temperature Monitoring
- Verification of Control
- Corrective Measures

- 1) Identification of mass concrete placements. Mass concrete is any placement with a minimum dimension of 4'.
- 2) Perform thermal modeling to predict maximum core concrete temperatures and surface-to-core temperature differences.
- 3) Maximum temperature and differential temperature control measures.
- 4) Curing methods
- 5) Temperature Monitoring (Hourly recording of remote sensors)
- 6) Verification (Monitoring is within the modeling criteria)
- 7) Corrective measures.

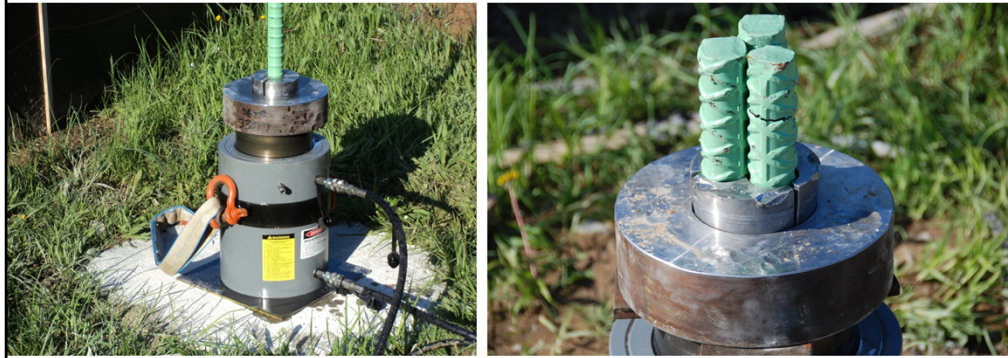
## Strengthening of Existing Piers (Caissons)

Contractor required to test caisson reinforcing method and can perform either production or non-production testing.

Contractor must use the exact equipment, materials, coring and grouting procedures which are to be used in production operations.

Reinforcing configuration must reach 90% of full yield strength without deformation of the reinforcing or bond failure of the high strength grout.

If failure occurs, contractor must modify materials or procedures and repeat tests until two test specimens are successful.

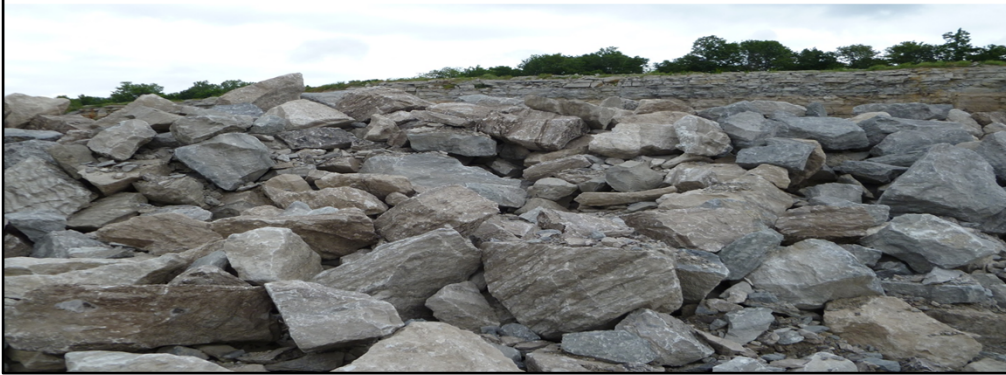
## Scour Countermeasures

- USACE Input
  - Specific Elevations and Dimensions
  - Specific Thickness
  - Specific Gradations
  - Specific Placement
  - Pre and Post Construction Surveys

Elevations and dimensions given in the plans.

Minimum thickness also given in case of a differing site condition.

Gradations from 11 inches to 36 inches given.

Riprap to be placed and not dumped.

Pre and post construction surveys to be performed to confirm placement.

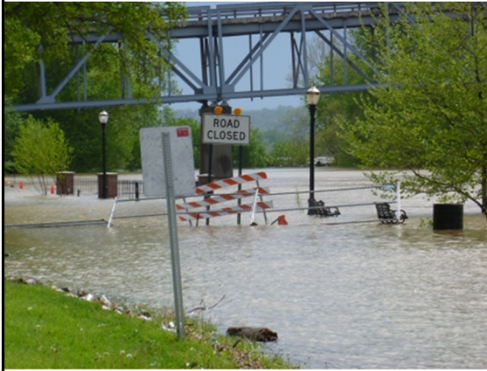
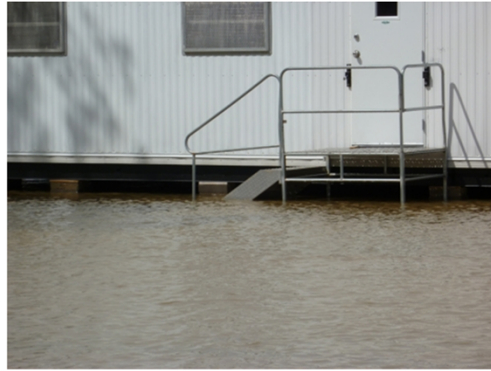
## Spring 2011 Flooding

8 Flood Events

131 Flood Days
